# Dinner Is Served

**Cured-in-place lining fixes a restaurant's problem cast iron drain line overnight while protecting a highly valued marble floor**

**Line 22 feet of a 3-inch drain line beneath an imported marble floor in a restaurant**

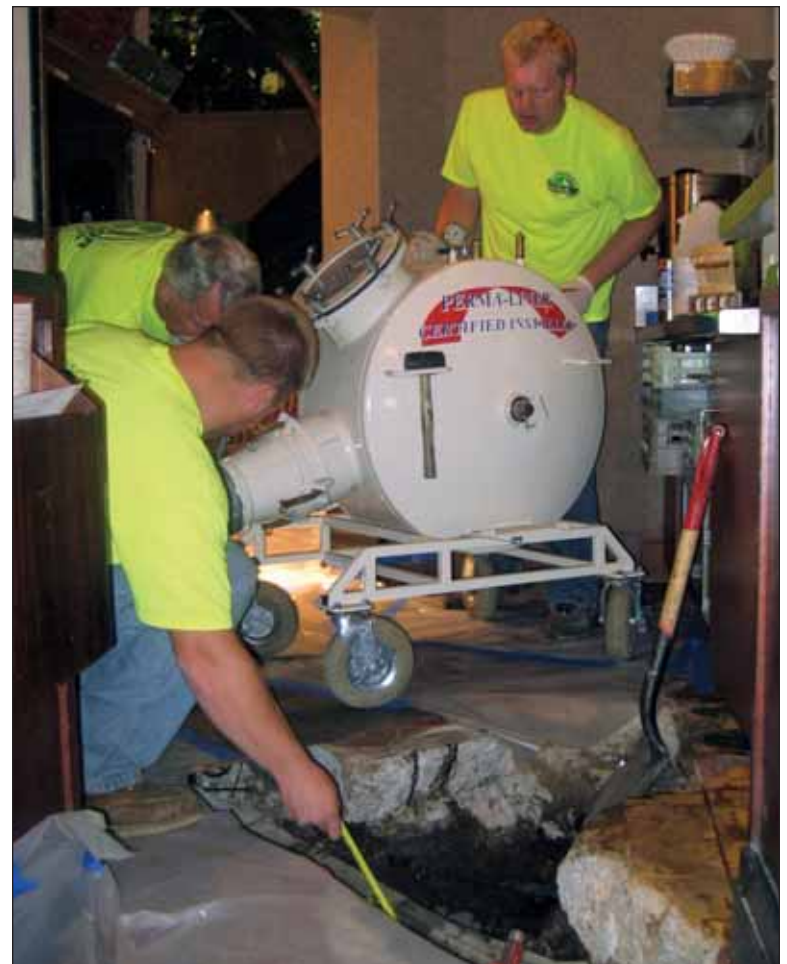
**Troy Ouverson (standing) and Doug Ouverson position the air inversion tank as Scott Veal measures the distance from the tank to the pipe about to be lined. (Photos from Troy Ouverson)**

The crew positioned the air inversion tank and every associated

item at the pit. Measuring the liner was critical, as it had to stop exactly flush with the air vent, yet cover the connecting joint. Walking at a fast pace, three men carried the felt liner

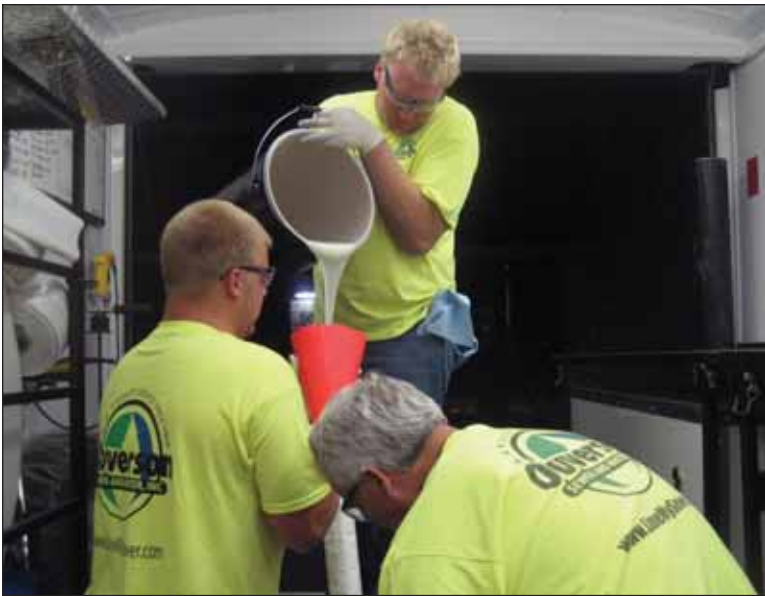
Troy Ouverson pours resin into a cone to begin the wetting-out process. Scott Veal holds the cone and Doug Ouverson assists him.

impregnated with a two-part medium resin from the trailer, then rolled it into the air inversion tank.

“Wetting out the liner and running it into the building took longer than shooting it,” says Ouverson. “Inversion took less than a minute at 6 psi. We hit the working and cure times almost perfectly. It was 70 degrees that night and slightly warmer inside.”
